# TEST REPORT

## Chemical resistance of materials

Protocol No. ....: 6053-22-GG-22-PP004

Description.....: Cable grommets

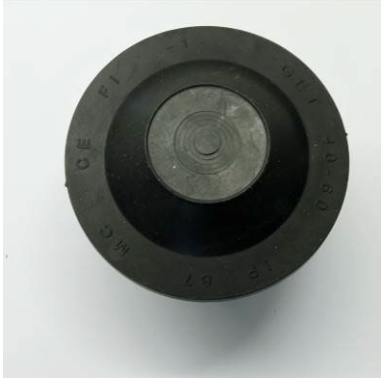
**Table 1: test samples**

SLG-sample no.	Type reference	Photo
6053-22-G/004	T-GET 40-60, material no. 100392 ONFLEX S FR 60A 3E1923 DEEP ; Mat.No. 20093822

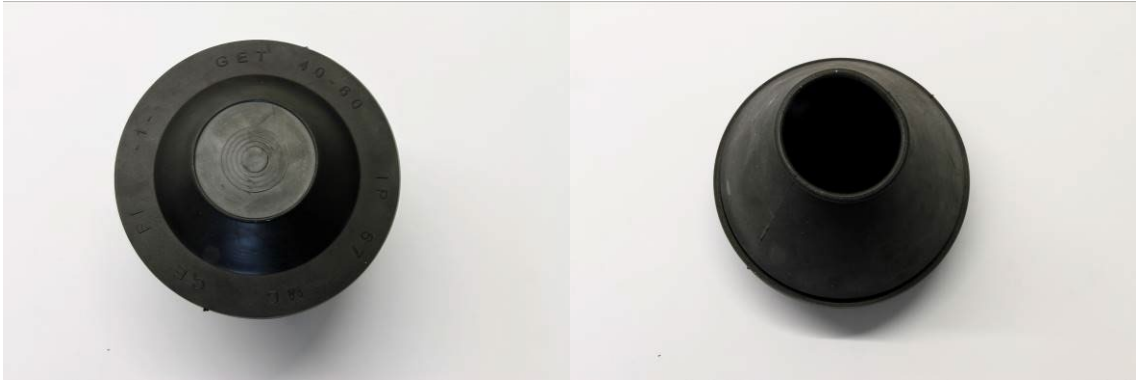
**Table 5: P3-topactive OKTO**

<b>Test medium</b> (test solution)	<b>P3-topactive OKTO / 3%</b>	<b>Result - Remark</b>
<b>Sample no.</b>	<b>Type reference:</b> T-GET 40-60, material no. 100392 ONFLEX S FR 60A 3E1923 DEEP	
G/004.01

<u>After 28 days:</u> No visible abnormalities <b>- RESISTANT -</b>

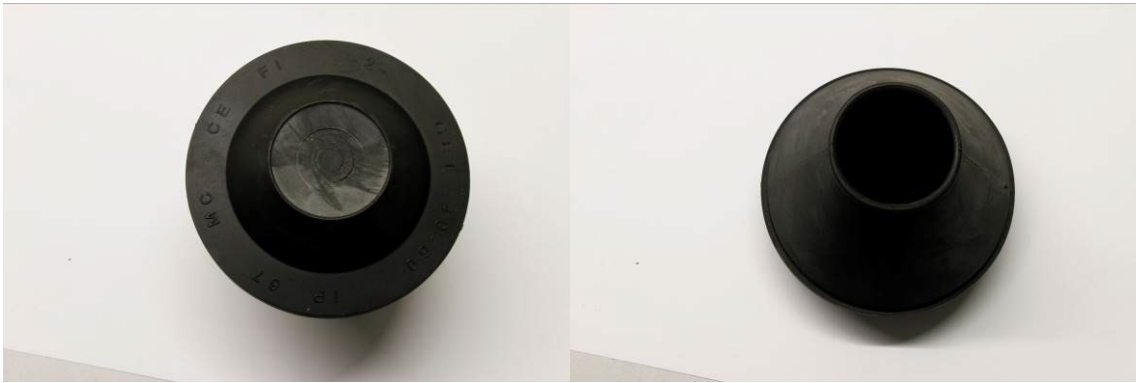
**Table 7: P3-topactive 200**

Test medium (test solution)	<b>P3-topactive 200 / 5%</b>	<b>Result - Remark</b>
Sample no.	<b>Type reference:</b> T-GET 40-60, material no. 100392 ONFLEX S FR 60A 3E1923 DEEP	
G/004.03

<u>After 28 days:</u> No visible abnormalities <b>- RESISTANT -</b>
