PROJECT: Lifters bar trial with Trelleborg Special Rubber Compound.

OBJECTIVE: TRELLEBORG Lifter Bars in Special Rubber Compound **Vs** Composite Steel Lifter Bars.

Inspection Form

WEAR MEASUREMENTS FOR LIFTER BAR TRIAL RUBBER(TRELLEBORG) Vs COMPOSITE STEEL.

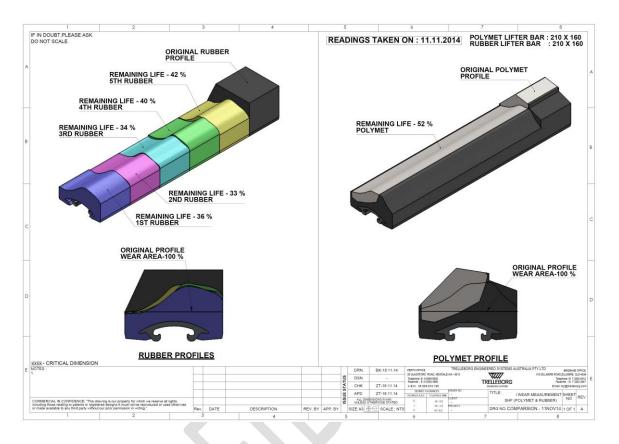
SHELL LINERS - AT FEED END: LIFTER 210-160

The difference in Rubber Lifter bars Vs Composite Steel lifter bars is only nineteen percent (19%) when compared with the 5th row of Rubber Lifter bar.

This once again goes to prove that the rubber will perform better if installed on its own, as one full ring.

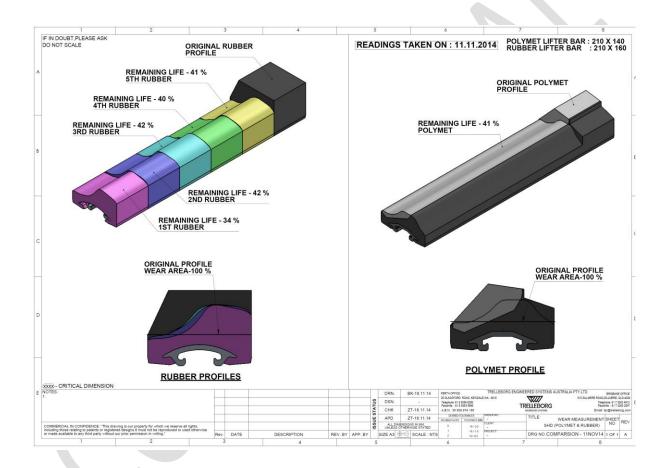
SHELL LINERS - AT DISCH END: LIFTER 210-140(COMPOSITE) 210-160(RUBBER)

No abnormal wear noted in Rubber lifter bars at this stage. Rubber lifters are on par (in terms of wear percentage remaining) in comparison to the Composite Steel lifter bars, which again is very encouraging, after **12 months** of operation.

It may be noted that the rubber lifter bars further away from the Composite Steel lifters are wearing better, this goes to prove that the rubber will perform even better if installed in one complete ring.
