Liner removal using PC 200 keeps Tokyo flowing

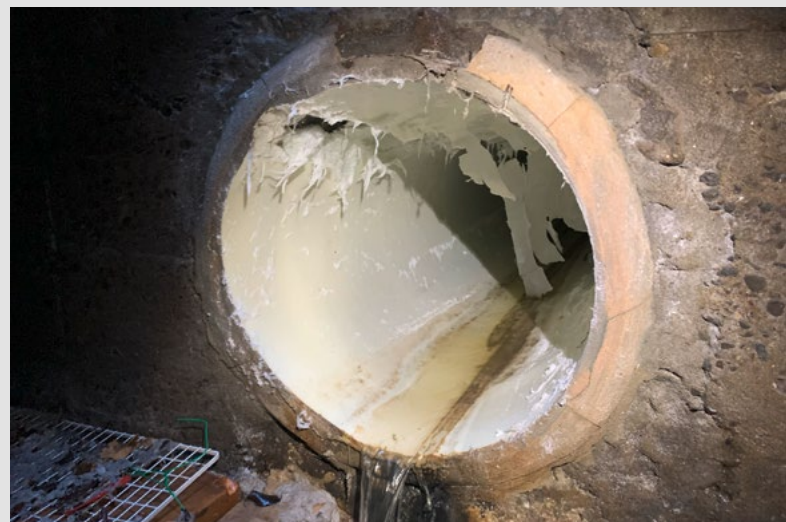
The CIPP liner was steam-cured and made of reinforced glass fiber, specifically manufactured to be corrosion-resistant for an aggressive wastewater environment. With this class of liner, the glass fiber is woven into the fabric. Compared to traditional polyester needle fleece knitted fabric, the liner's unique make-up strengthens its mechanical

properties, allowing it to withstand higher pressure of the waterflow. However, it also makes the liner material more challenging to remove when things go wrong.

BVS used a combination of milling and high-pressure water-jetting to remove the failed liner. Importantly, the liner needed to be cut into separate pieces to be lifted above ground via existing manholes. The exact length of each section being cut depended on the size of the manhole. In total, the project team needed to account for five different manhole dimensions, with diameters ranging between DN 900 and DN 1,200. Cutting was performed using Trelleborg's state-of-the-art robotic cutter, PowerCUTTER 200, controlled by an operator above ground via a console, and monitored via CCTV.

The robotic cutting work was performed by a single operator supported by three workers for approximately six days. After robotic cutting of the defective liner from the pipe, the BVS team removed it from the manhole over a further four days in smaller 50 cm pieces. The entire process of removing the failed liner was successfully completed in less than 10 days.
