Tightness tests for IP66
- MC1 Splitting d34mm

Assignment Tightness tests for IP66.

Sample details MC1 Splitting d34mm.

Methods IEC 60529:1989+AMD1:1999+AMD2:2013.

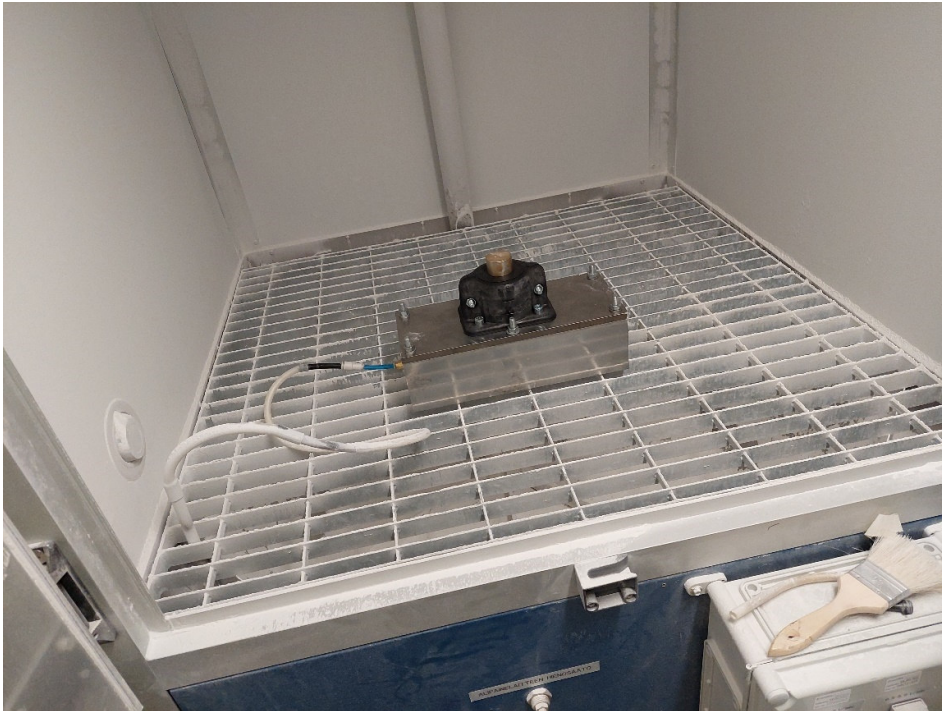
Photograph 1. EUT in the test chamber.

For the dust test the EUT was placed in the dust chamber provided with talcum powder circulation. The underpressure pipe was connected on the side of the accessory box. The test parameters were following:

- Underpressure 2 kPa
- Flow rate of the air 0,2 l/min
- Test duration 8 hours
- Ambient conditions: $(+21 \pm 2) ^\circ\text{C}$ / $(38 \pm 5) \% \text{RH}$
- Test date 13.4.2023

In the visual examination after the test no deposit of dust was detected inside the accessory box.

Based on the test results the protection against dust complies with the requirements stated for the protection class IP6X.
