# Case Study

## IMPROVING QUALITY OF LIFE BY TACKLING PIPE LEAKAGE PROBLEM IN INDIA

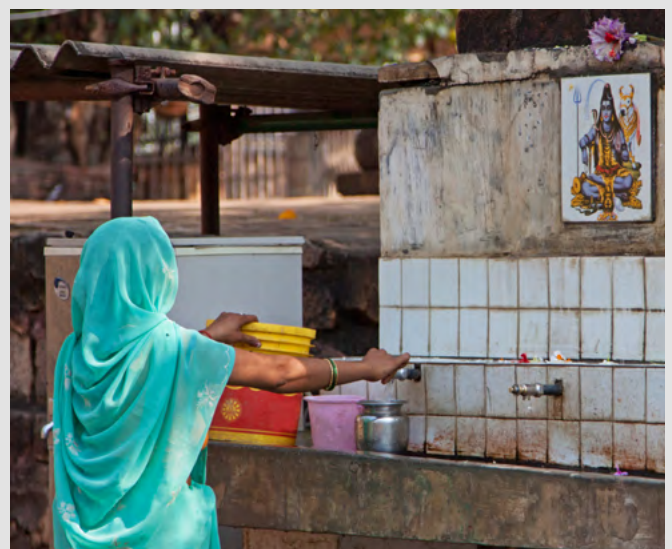
The leakage of sewage pipes in India attribute to many factors, among which is the offset joints, meaning that the end of the two pipe segments is not properly aligned. Offset joints is the result of improper pipe installation, for example, one end of the pipe is not fully inserted into the other end, leaving gap that allows water to seep out. Loose seals inside the groove, aging brittle seal rings, unfit seal rings that are unable to provide the necessary positive pressure environment inside the pipe are other common reasons that cause pipe leakage.

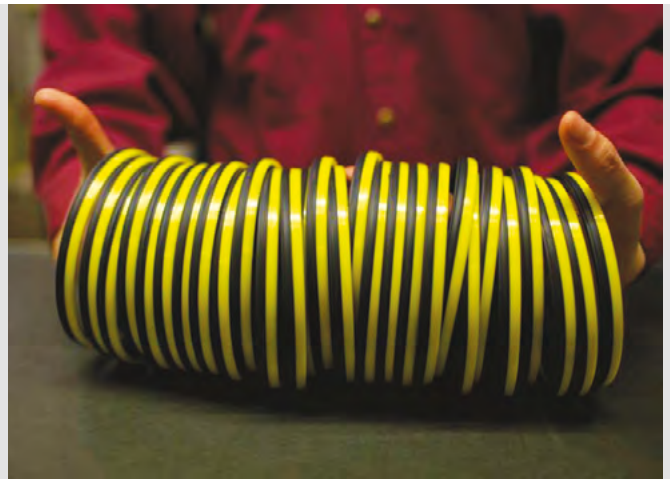
Trelleborg 582 Din-Lock is expertly designed for highly effective sealing of all DIN grooved plastic pipes and fittings. Comprised of thermoplastic elastomers (TPE) and Polypropylene, the seal requires low jointing force and ensures security across a wide range of pipe joint tolerances. The Trelleborg 582 provides a combined lip and compression seal, which is firmly locked into the pipe socket. This special design has eliminated the problem of the seal moving inside the grooves and provide leak proof solution.

The soft plastic reinforcement allows the seal to be fitted easily into the pipes socket by hand-bending the seals. The installation process for each seal is finished in 10 seconds, which is much more efficient compared to traditional jointing methods, such as applying glues, or fusion jointing.
